Reduction of landslide risk in substituting road of Germei-Chay dam

ABSTRACT: Germei-Chay dam is an earth-fill dam with central clay core that is underconstruction across the Germei-Chay River in Iran. Due to dam construction, part of the main road, that connects East Azerbaijan and Ardabil provinces together, remains within the dam reservoir. Therefore, it is necessary to construct a substituting road, 5 km long, outside of the reservoir. Part of the substituting road is located on the natural ground slope is susceptible to landslide. In this paper, first, the stability of the road slope is verified by performing a back analysis for the slip surfaces. Then, an appropriate scheme is suggested for construction of the road embankment in order to attain permanent stability of the slope. Evaluation of measured deformations show that the slope displacements have decreased considerably and slipping of the slope have stopped after executing the stabilization treatment.

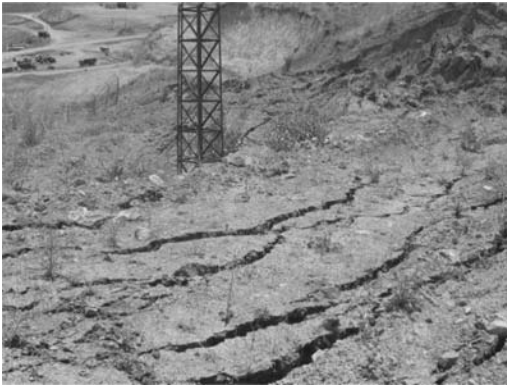
Figure 1. Tention cracks near borehole BH 55 due to slipping.

The geological investigation of the area shows that the slope is comprised of weak shale material located on the igneous bedrock. Furthermore, a waterway has been located in the vicinity of subgrade slope. So that during the rainy seasons, ground water rises within the slope and causes to occur slips and tension cracks in the subgrade slope. Field measurements indicate that the values of horizontal and vertical displacements during 9 months are 714 and 346 centimeters, respectively. A view of cracks and slips occurred in the subgrade slope are presented in Figures 1 and 2, respectively.

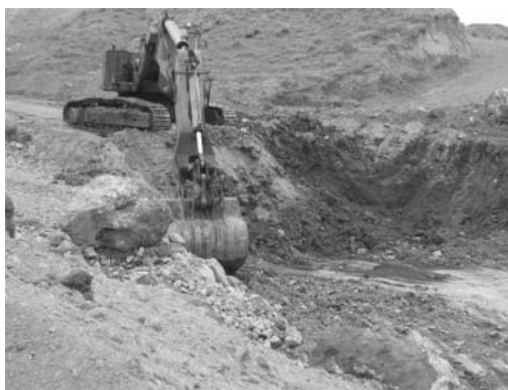
Figure 7. Excavation and filling processes of the strips during construction.

For excavating road embankment foundation located on the slipped area, it is divided into a number of narrow strips (about 3 meters width) perpendiculars to the longitude axis of road.

To avoid any instability within the slope during construction process, each strip was first excavated from downstream to the upstream of the slope and then filled with rockfill material until reaching to original ground level. Then, the adjacent strip was performed similarly. This operation was executed for all strips until the weak shale material of the road subgrade was substituted with the strong rockfill material. Since the least depth of the bedrock located at the east north of the embankment, the excavation and filling processes was commenced from this situation.

Figure 7 shows the excavation and filling processes for one strip of road foundation. Also, the embankment of substituting road after completion is shown in Figure 8.

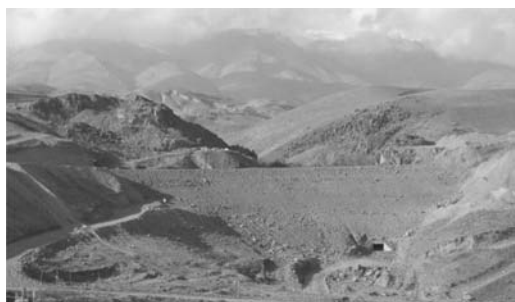
Figure 8. Embankment of substituting road after completion.

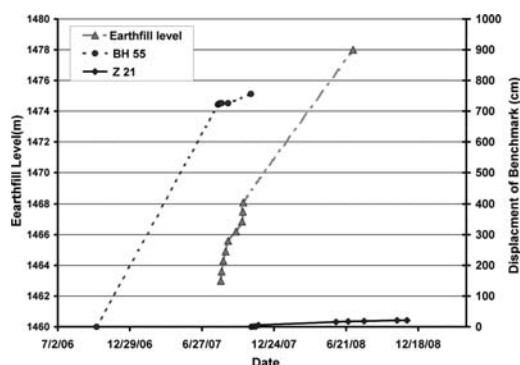
Figure 9. Measured accumulated displacements at benchmarks located on the slope and construction level of earthfill.

regularly at the benchmarks. The investigations showed that the considerable reduction occurred in the deformations after construction of road embankment. For example, variations of displacements during and after construction at the benchmarks located near the BH-55 borehole and Z21 are presented in Figure 9. In this figure, the horizontal displacement of the benchmark located on BH-55 borehole is 721 cm before the road embankment construction (from Oct.-2006 to July-2007). So the average rate of horizontal displacement is equal to 2.38 cm/day. Although during construction of embankment (from July-2007 to Oct.-2007), the displacement of this benchmark shows considerable reduction. Unfortunately, during construction operation, this benchmark is destroyed and inevitably another benchmark (i.e. Z21) was installed in the slip direction and slope behavior was investigated via monitoring displacements in this benchmark.

The site surveying during road construction indicated that the accumulative value of displacements in the benchmark Z21 at the similar rainy season is 16 centimeters (from Oct-2007 to May-2008) and its average rate is about 0.7 mm/day. Comparing the displacements of the two benchmarks at similar time intervals indicates that the deformation of sub-grade slope has decreased about 34 times. During

embankment construction, the displacement of Z21 increases only about 4 centimeters (from May-2008 to Oct-2008). After embankment completion up to now, the movement of benchmark Z21 and subsequently the slips of slope are almost stopped.
